QUALITY ALERT HO.01.06.0048

Title: 200LX Second Stage, Voluntary Recall (Consumer)

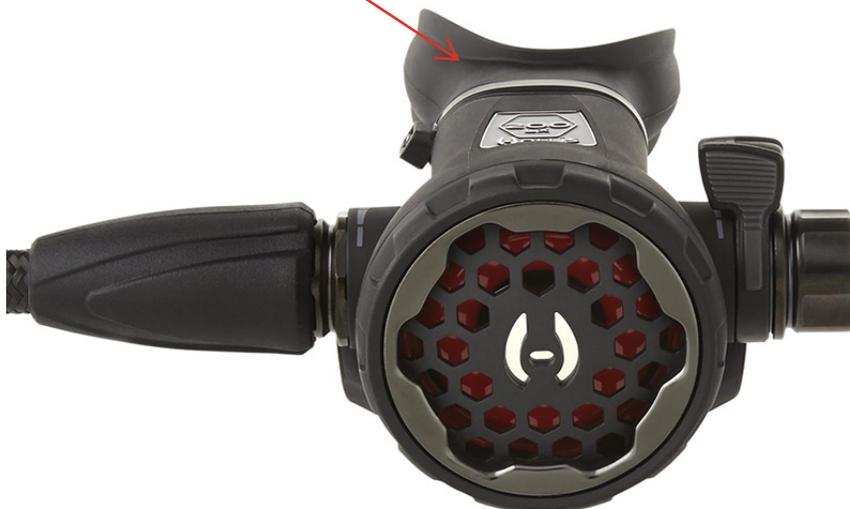
#### **How to Identify the 200LX second stage:**

Top of the 200LX second stage housing will have a label which indicates the model: "200LX Hollis". Important to also check the serial number listed under the mouthpiece to confirm whether it is within the affected range.

The replacement part necessary for this quality alert is an upgraded stainless steel inlet tube which replaces the original brass version. Below is the part number and description of a “**LX Inlet Retrofit Kit**” – **PN 01.000313**. This kit includes the following components:

It is of the utmost importance that if you have a regulator affected by this quality alert, that you stop use and have the inlet valve replaced as soon as possible. It is recommended to destroy any of the inlet tubes found within the affected range.
